The Earth Rangers Centre recently addressed this type of maintenance when working through the [LEED for Existing Buildings: Operations and Maintenance certification](#) by performing a thermal scan of the building. Gratton Infrared, certified thermographers, took images of the exterior of the Earth Rangers Centre with an infrared camera. This camera recognizes temperature differences and shows them in a colour scheme that can be interpreted as heat loss (or gain). Note that interpreting thermal images takes experience, as some images show colours/temperatures that don't seem to make sense. This can be a result of reflections, camera angle, outdoor conditions and other factors that the thermographer can identify. In some cases, the thermographer will adjust the scale of the temperature gradient to be able to visually identify all the elements in the image.

Two exterior doors were noted as opportunities for energy savings and improved occupant comfort during the scan. The rotating door leading to the reception area and a metal door leading from the theatre to the outdoor patio were noted in our scan.

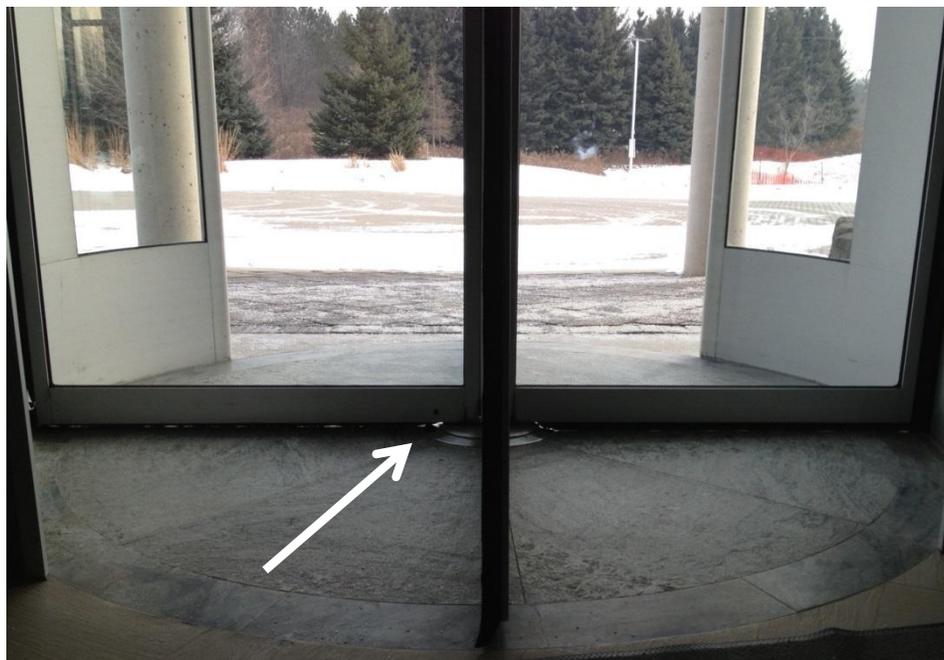
Figure 1: Rotating Door - note visible gaps under door seals

The rotating door had been a noted issue for years. Weather stripping needed to be adjusted weekly during the coldest parts of the year. Complicating this, the floor was uneven, so the seals really didn't work properly. Also, the single pane glass in the door assembly bled heat out of the space. The result was that our receptionist needed an inefficient electric space heater to keep warm. Not ideal in a highly rated LEED building that's known for its frugal use of energy!

The rotating door was replaced with an SL500 EcoDoor from Besam, an ASSA ABLOY brand. It features two sliding mechanisms, dual pane insulated glazing, magnetic latching and an interior vestibule.

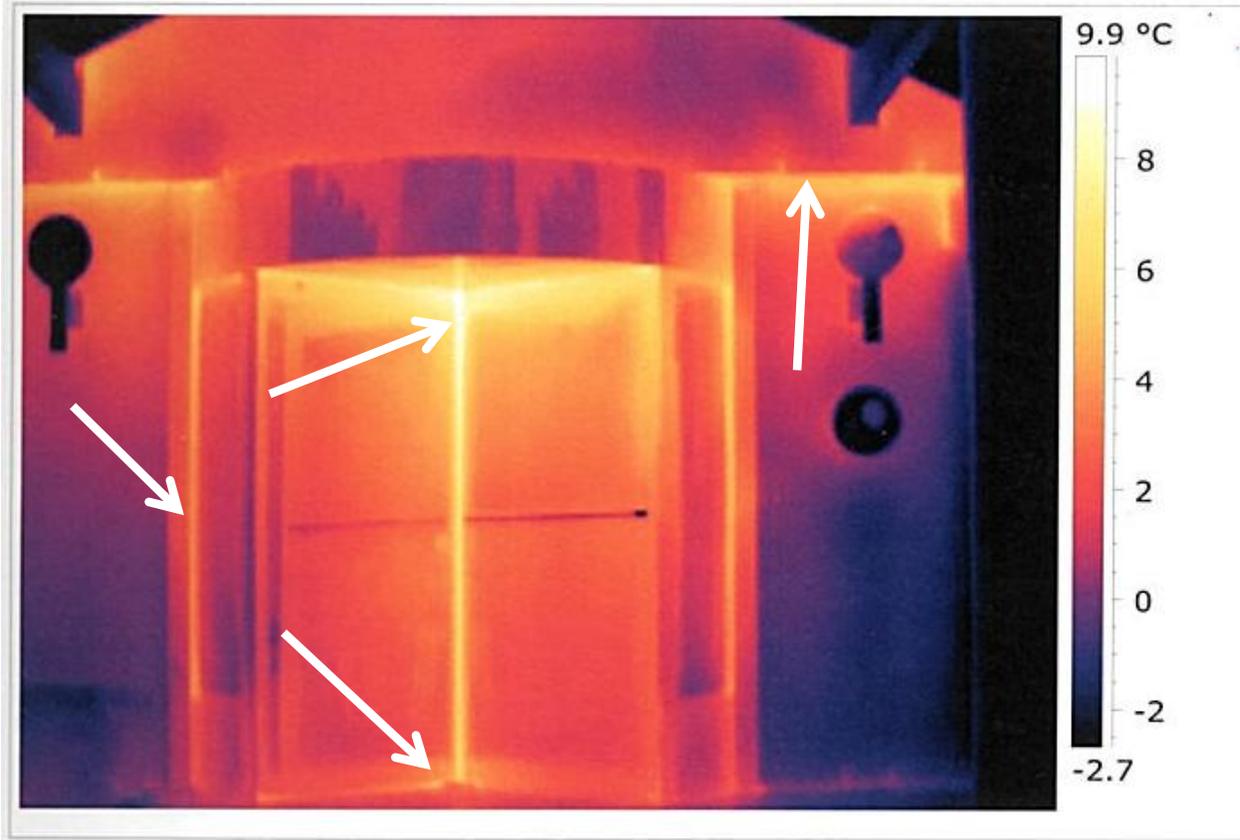
Figure 2: Thermal loss shown at joints and seals

A thermal image of the rotating door was taken in March of 2011, with an outdoor temperature of 1.5°C. Figure 2: Thermal loss shown at joints and seals Figure 2 shows the result of one of these images. The white coloured areas indicate a surface temperature greater than 10°C. The temperature difference between this surface and the outdoor air enables heat loss through convection, conduction and radiation to the outdoor environment. Note that this image was taken when the door was in its ideal (locked) position. Under normal daily use, it was left in different positions, like in Figure 1, which would make heat loss and drafts worse.

The reception door was removed and replaced in September of 2013. Interestingly, the space above the rotating door did not have any insulation in it at all, resulting in the “hot” edge above the door in Figure 2.

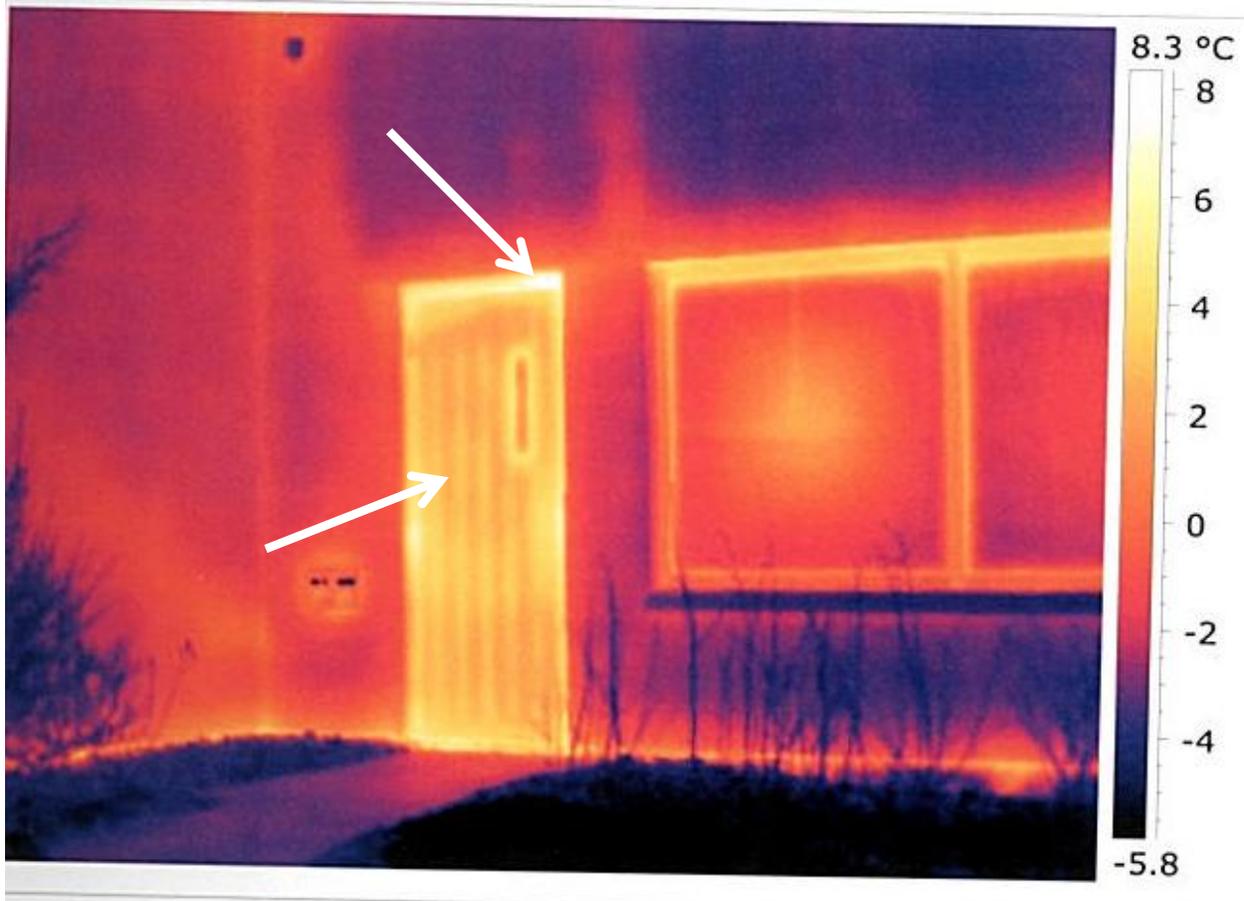
The Centre also received occupant complaints about the drafts near the metal egress door from the theatre.

Figure 3 shows a similar image for a typical metal stiffened door on the building exterior. Note the “thermal bridging” evident as the bright yellow vertical stripes on the door.

Figure 3: Metal door heat loss

On a tour given to representatives of ASSA ABLOY Door Security Solutions Canada, it was decided to replace these doors and evaluate the performance improvements.

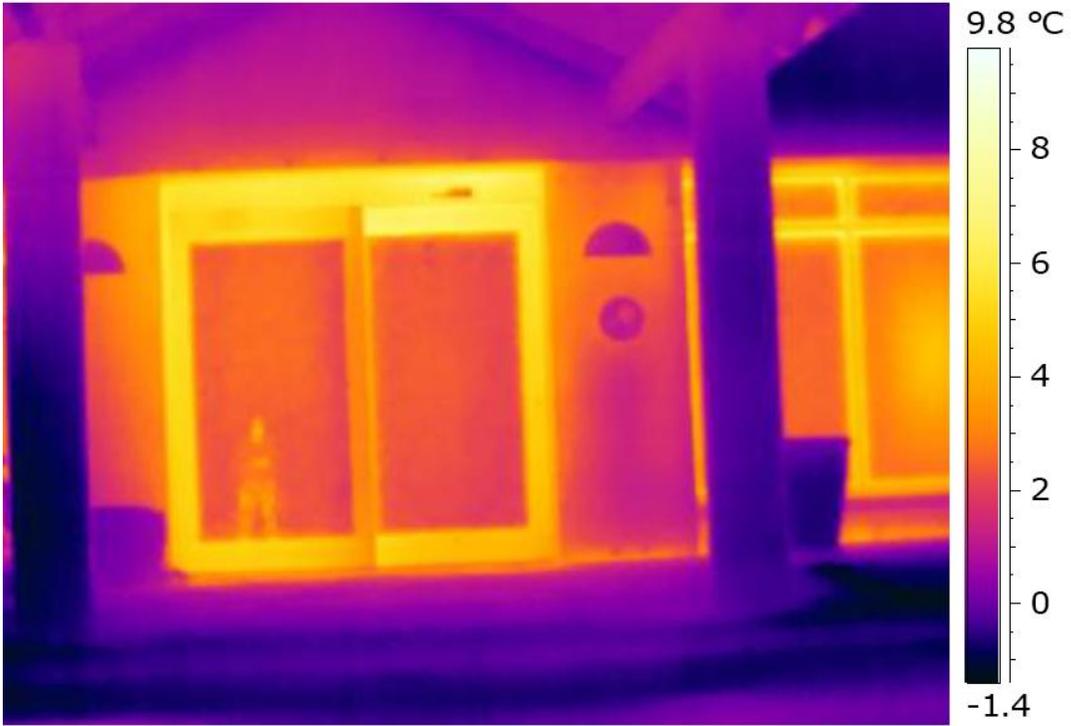
Figure 4: SL500 EcoDoor heat loss

Immediately evident in the scan in Figure 4 are the cooler temperatures on the door surfaces. Note that there is almost zero leakage evident around the seals. In addition, the interior bulkhead was properly insulated and caulked this time, reducing the heat loss at the top of the frame, at the connection between the door frame and building.

The glass temperature on the new door is also noticeably lower than the old rotating door. This is a result of higher quality, better insulating value glazing.

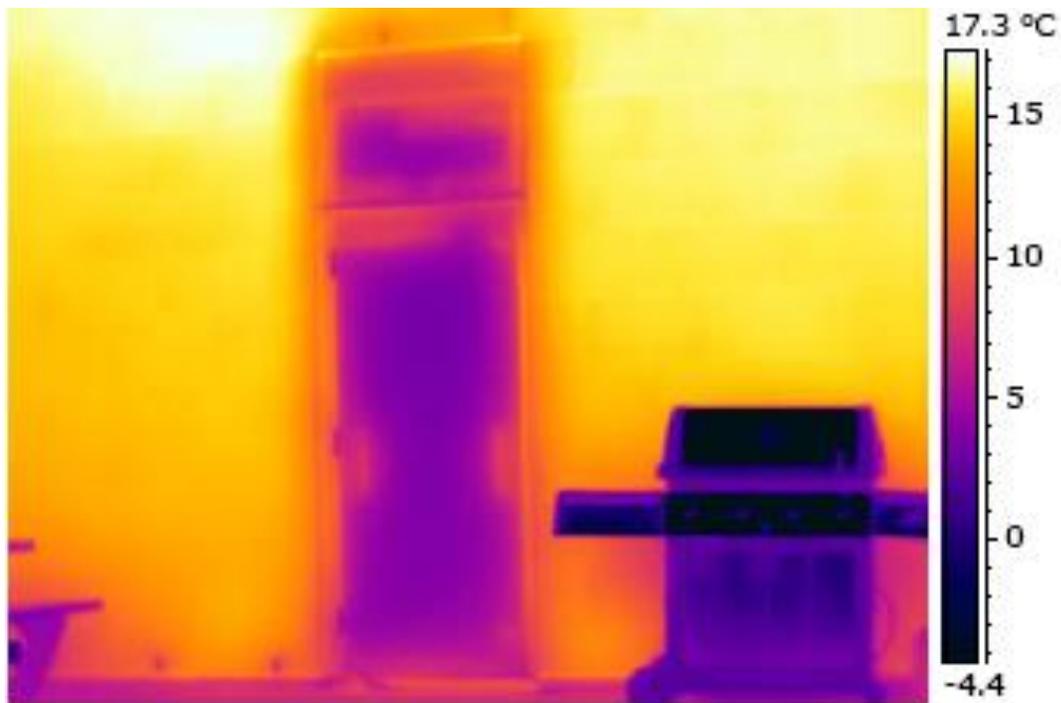
Figure 6: TRIO-E Door heat loss

When comparing to the door in Figure 3, the metal reinforcing bars are not visible, indicating better insulation value. Also, the seals around the door are not high on the temperature scale. They're sealed well.

This wall is south facing, and so this wall had been absorbing winter sun all day, warming it relative to the surrounding areas. This is why the wall seems so warm. The image was taken at 5pm, and the wall had likely not yet cooled from the late afternoon sun.
